# ROAD SAFETY AUDIT

Watertown Street (Route 16) at Galen Street

Town of Watertown

November 4, 2016

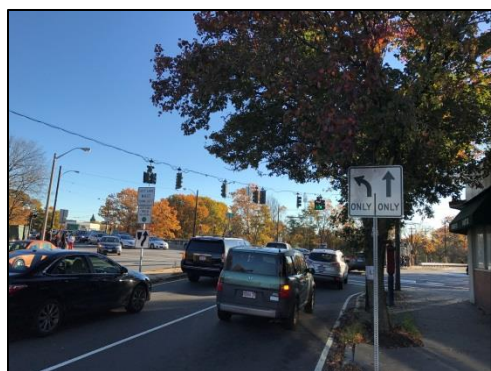
Twelve crashes occurred between vehicles turning left from Watertown Street eastbound and vehicles traveling through on Nonantum Road westbound. Watertown Street eastbound left-turns operate with a protected-permissive left-turn phase, where the protected left-turn phase is lagging, occurring after the permissive phase. These crashes may occur for several reasons. Motorists may not be aware that a protected phase is upcoming after the permissive phase, and may feel the need to eventually find a gap in opposing westbound traffic.

**Watertown Street eastbound receives a lagging left-turn phase. Vehicles may get stuck in the intersection, or unable to proceed, during this phase due to congestion north of the intersection.**

1. Consider the possible operational and safety benefits of switching to a leading left-turn phase on Watertown Street eastbound to allow left turning vehicles to turn left without conflict before conflicting vehicles enter the intersection. Consider possible impacts to signal coordination and queue lengths from the Watertown Square intersection.

2. Consider installing a flashing yellow arrow indication at the Watertown Street eastbound approach to the intersection so that motorists are aware when they may freely turn left and when they must yield to oncoming traffic.

3. Consider the safety benefits of converting to protected-only left turns on the Watertown Street eastbound approach. Consider potential operational implications, including increases in delay for all approaches to the intersection as well as queue lengths on Watertown Street. This improvement may also allow for concurrent pedestrian phasing at the intersection, which may improve operations and improve pedestrian mobility.

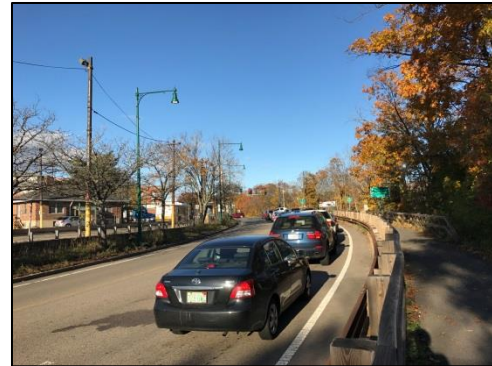
The alignment of Nonantum Road may make it difficult for westbound motorists to see the signal indication at the intersection. A horizontal curve about 400 feet upstream of the intersection blocks the signal indications from view, and vehicles traveling towards the intersection may not have time to stop for

a red indication or vehicles queued at the stop line. Tree growth along the inside of this horizontal curve may further impede visibility of the signal indications.

**A horizontal curve on Nonantum Road may make it difficult for motorists to see the signal indications at the intersection.**

7. Consider placing “(Red) Signal Ahead” signs with illuminating “Red” text on the Nonantum Road westbound approach to the intersection so that westbound vehicles can anticipate a red indication as they approach the intersection.

10. Trim trees along the Watertown Street eastbound approach and the Nonantum Road westbound approach to the intersection so that the signal indications are visible to motorists.

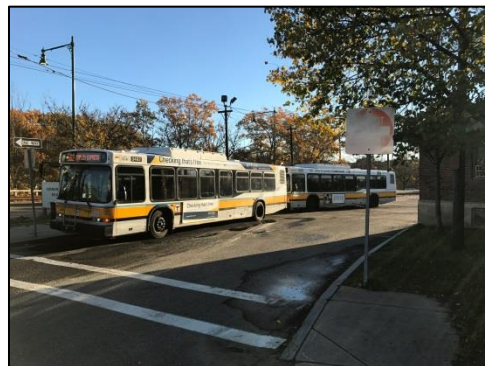
**The Watertown Yard bus terminal is a heavy pedestrian generator at the southeast corner of the intersection. Pedestrians often cross the intersection from all directions to get to the bus terminal.**

3. Consider moving the crosswalk across the southern leg of Galen Street to begin north of the Watertown Yard busway so that pedestrians do not have to cross the busway driveway and so that the crossing can be included in the exclusive pedestrian phase. Consider that this enhancement would require a new pedestrian ramp on the eastern side of the crossing.

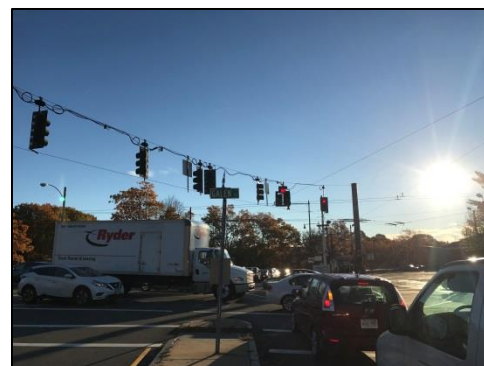
Most of the crosswalks at the intersection of Route 16/Galen Street are striped with transverse crosswalk markings only, with the exception of the crosswalk across Nonantum Road, where longitudinal lines were used. Combined with the “Do Not Block the Intersection” markings at the intersection, the location of the marked crosswalk can be unclear to pedestrians and motorists. Motorists may be more likely to block a marked crosswalk in this case, causing pedestrians to cross in locations where they may not be expected.

**Crosswalk markings are not easily distinguishable from “Do Not Block Intersection” markings. Vehicles often stop in the crosswalks, forcing pedestrians to walk between queued vehicles.**

2. Restripe the crosswalks at the intersection of Route 16/Galen Street with high-visibility continental crosswalks to differentiate the crosswalk from the “Do Not Block the Intersection” markings and make them more visible to motorists, pedestrians, and bicyclists.

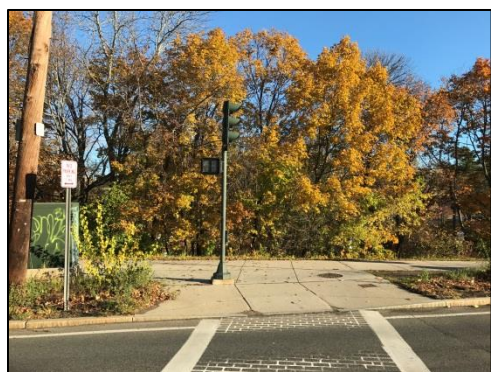
**The “Don’t Walk” indication at the pedestrian signal across California Street does not work.**

The “Don’t Walk” signal on the Watertown Street westbound right-turn approach onto California Street at the intersection of Watertown Street/California Street was not working at the time of the audit. The “Walk” indication was functional, and sufficient clearance times were provided. The missing “Don’t Walk” indication may signal to pedestrians that they have the right-of-way even when motorists have a green indication. One crash involving a pedestrian occurred on this approach.

8. Replace the malfunctioning “Don’t Walk” signal at the pedestrian crossing across California Street.
9. Consider placing “Use Ped Signal” (R9-5) signs to inform bicyclists to use the pedestrian signal when crossing Galen Street along the Charles River Greenway.

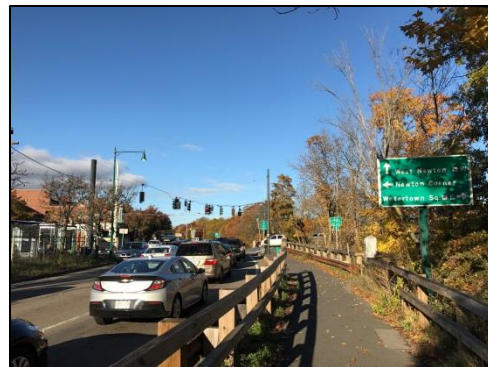
**Guide signs on Nonantum Road is difficult to read and located close to the intersection.**

2. Replace text guide signs with clear signage using route number shields where applicable. Guide signs should be placed in advance of the intersection so that motorists can shift into the appropriate lane.

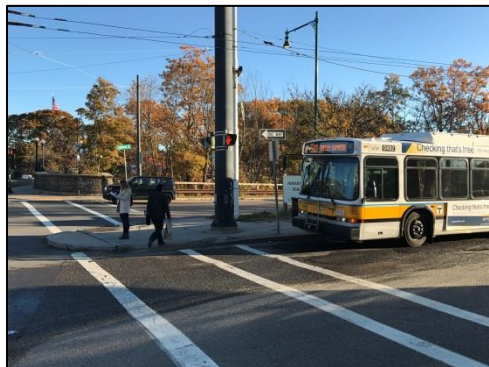
**The Watertown Yard bus terminal exit is located just south of Nonantum Road.**

The bus terminal's exit is located just south of Nonantum Road. RSA attendees noted that it may appear to Galen Street northbound motorists that the bus terminal exit is actually the eastbound side of Nonantum Road, as the driveway is located north of the stop line for that approach. One-way and Do Not Enter signs at the exit is aging and may not be visible to motorists.

2. Replace aging One Way and Do Not Enter signs at the Watertown Yard exit driveway so that motorists are less likely to mistakenly enter the driveway.
